1. Church of the Redeemer, Rockport, ON

2. St. Philip's Church, Milford, ON

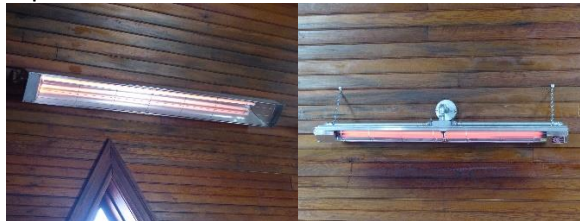
The church is heated with 8 infrared (IR) heaters located at the top of the vertical wall and pointed about 45 degrees from wall towards the centre of the church: three on each side of the nave, and one on each side of the sanctuary. Six of the heaters (installed in 1992) are about 1.5 metres long, and two more recent (in 2014, at right below) measure about 1.2 metres. When active, red-hot heaters 'shine' infrared radiation that warms up

the first surface it encounters: people, pews, floor etc. A heater illuminates an area from the wall to about the centre of the church, although the heat is strongest near the wall (due to it being closer to the heater than the centre of the church). Although the heat is near-instantaneous, achieving a pleasantly warm environment for occupancy requires that the heaters operate for about two hours prior to the event; during this time, the ambient air also warms up from the contact with the warmed surfaces, and through the contact with the warm air other objects also warm up somewhat. The heaters are turned off shortly after the service begins since by then the heat is sufficient to last during the entire service. No heat is provided during the week, so the church gradually cools down to a temperature near-equilibrium with the outside air; the rate of cooling and the minimum value depends on the outside temperature during the week.

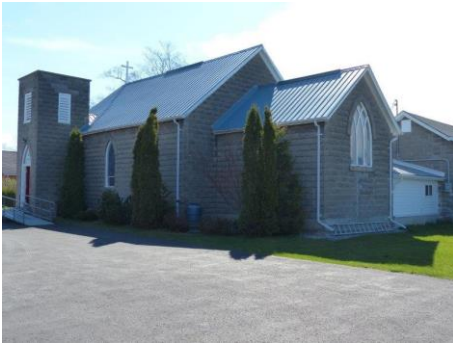
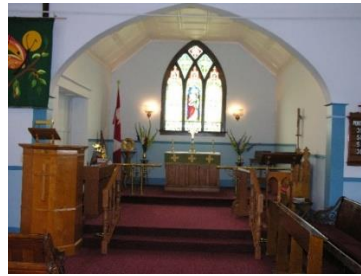
St. Philip's Church building in Milford, ON consists of several parts: the entrance through a small vestibule through the tower at left, the nave and sanctuary, a Sacristy connecting to the office (in white above), and a hall with adjacent kitchen next to the office.

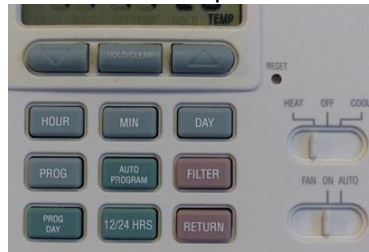
Programmable thermostat for temperature controls.

The temperature during the winter is set at 6°C on the programmable thermostats, and at the minimum (=10°C) on the others. In the colder months, the programmable thermostats are used to provide a temperature of 20°C for Sunday services. They are set at 15°C at 8:00 a.m. and at 20°C at 8:30 a.m. to achieve the desired 20°C in time for the service at 11:00 a.m. The conditions for proper heating are correct thermostat setting, good batteries in the thermostat, AND closed doors to the outside.

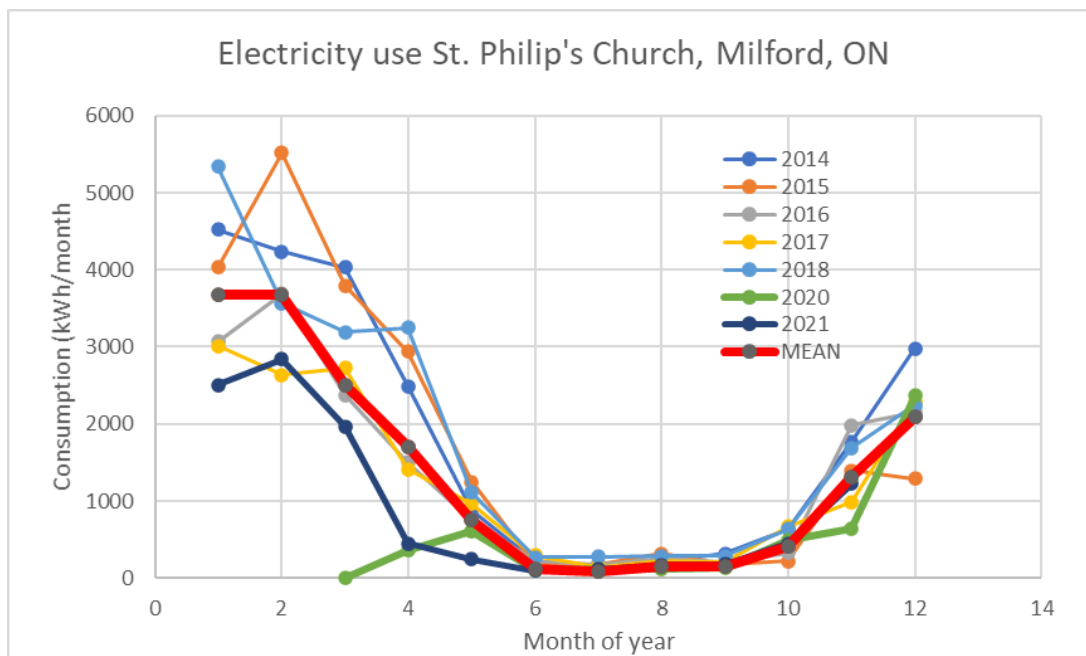
The most detailed record of energy use are monthly invoices sent by Hydro One. These list both consumption and cost, for the last several years also recording separately daytime and overnight use (because these are sold at different rates). Using the monthly invoices since 2014, the following graph has been prepared (the first two values for 2021 are not available).

The graph shows that:

- Heating during the winter uses most of the electricity. The six months November-April use about 88% of all electricity consumed, while the six summer months use only 12%. For the same reason, the COVID years (2020, 2021) did not differ greatly in electrical consumption.
- The interannual outdoor temperature variability during the cold season results in substantial differences in heating costs.
- Considering the heated areas only, the annual consumption is about 16500 kWh, or 45kWh/day or 1.9kWh/hour; and with the total heat area of 220.6 m², 75kWh/m²/year.
